DEBRIS/ICE/TPS ASSESSMENT  
AND  
PHOTOGRAPHIC ANALYSIS  
OF  
SHUTTLE MISSION STS-32R

January 9, 1990

Gregory N. Katnik  
NASA/Kennedy Space Center  
TV-MSD-22

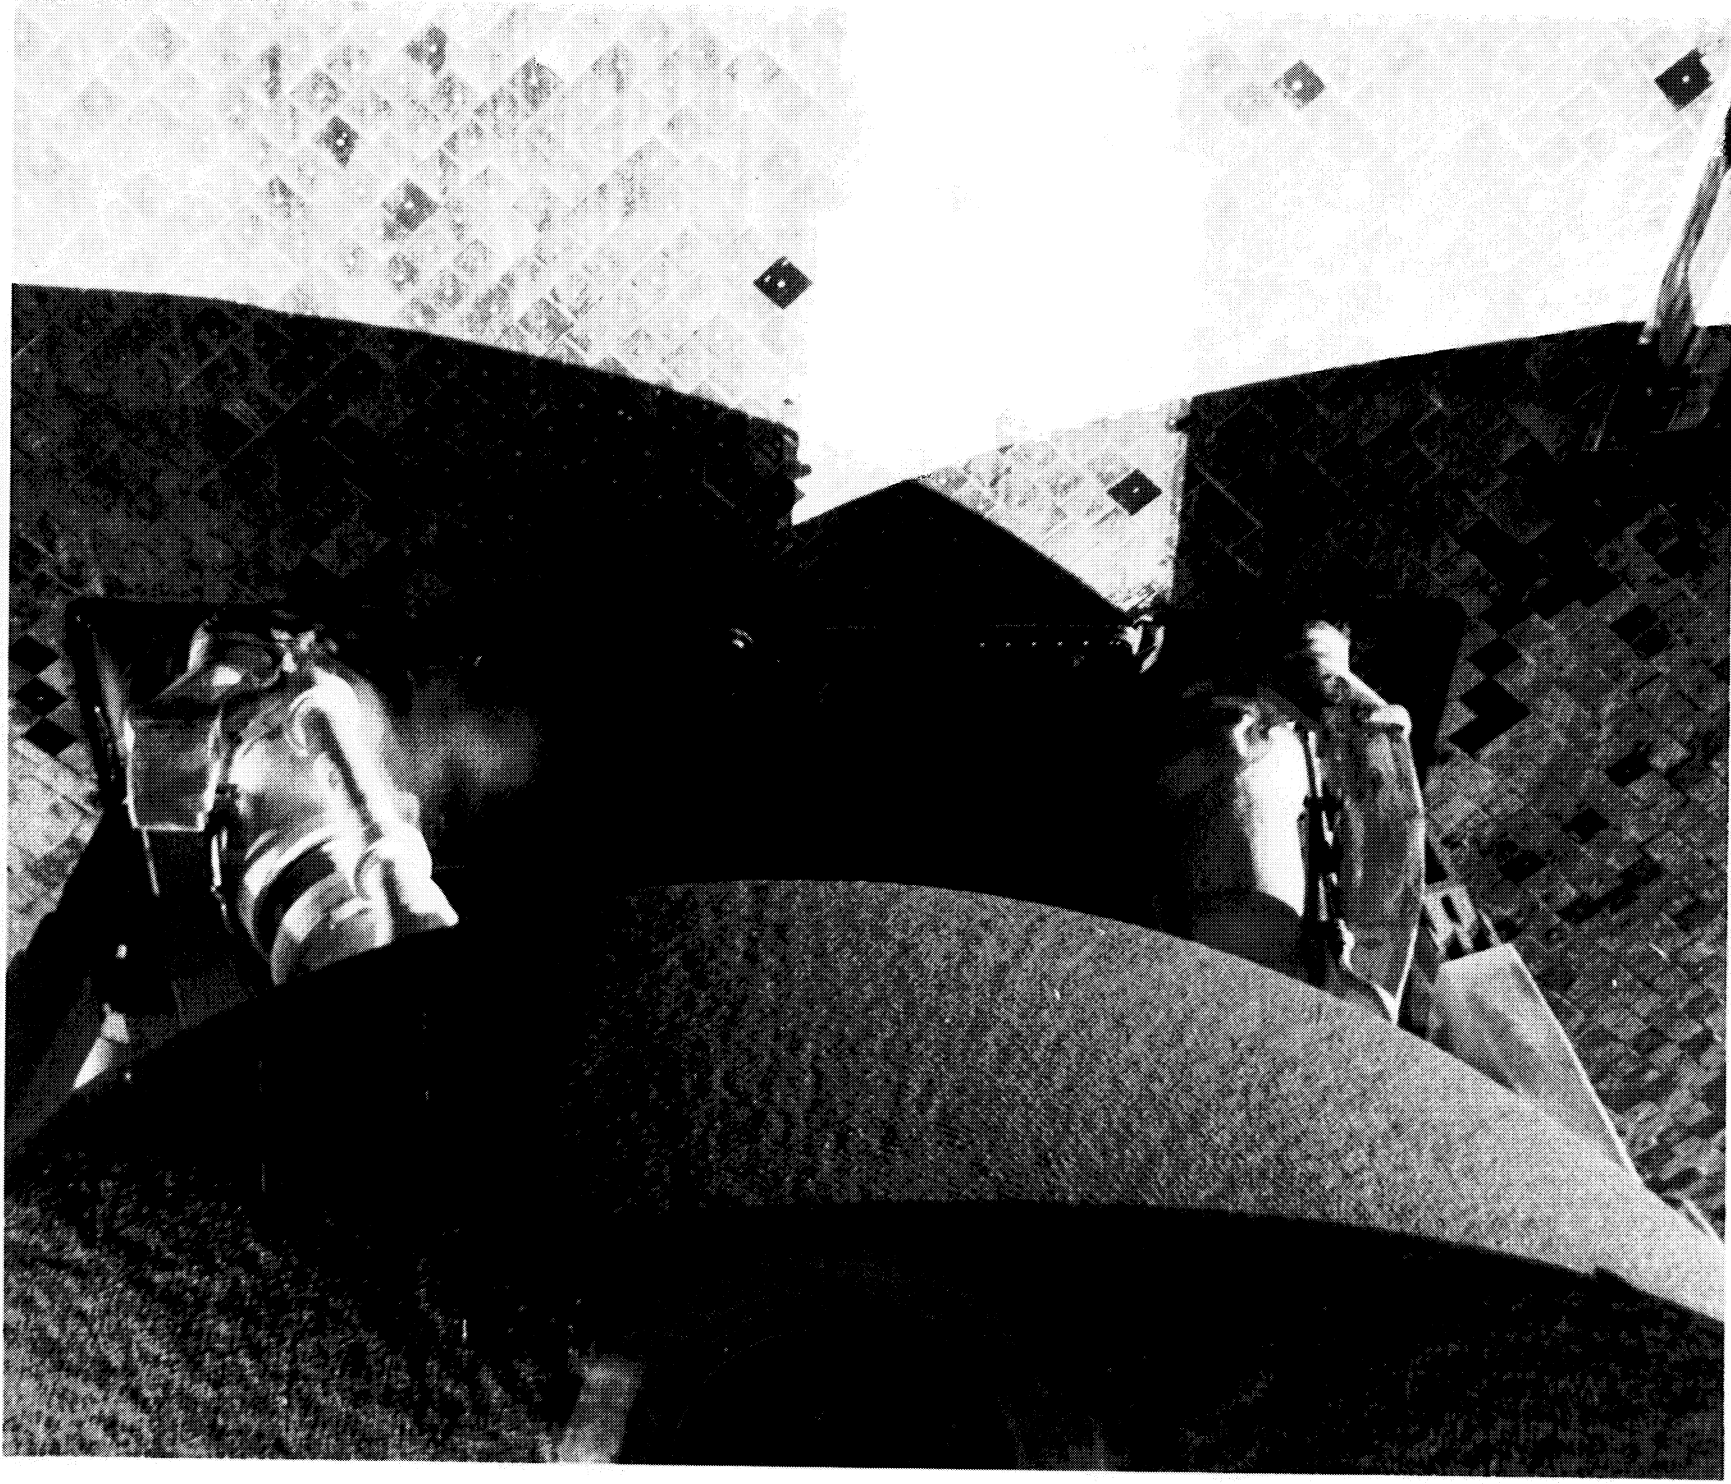
Ice/frost formed on the aft side of the LO2 umbilical, in the  
LH2 recirculation line bellows, and on all purge vents

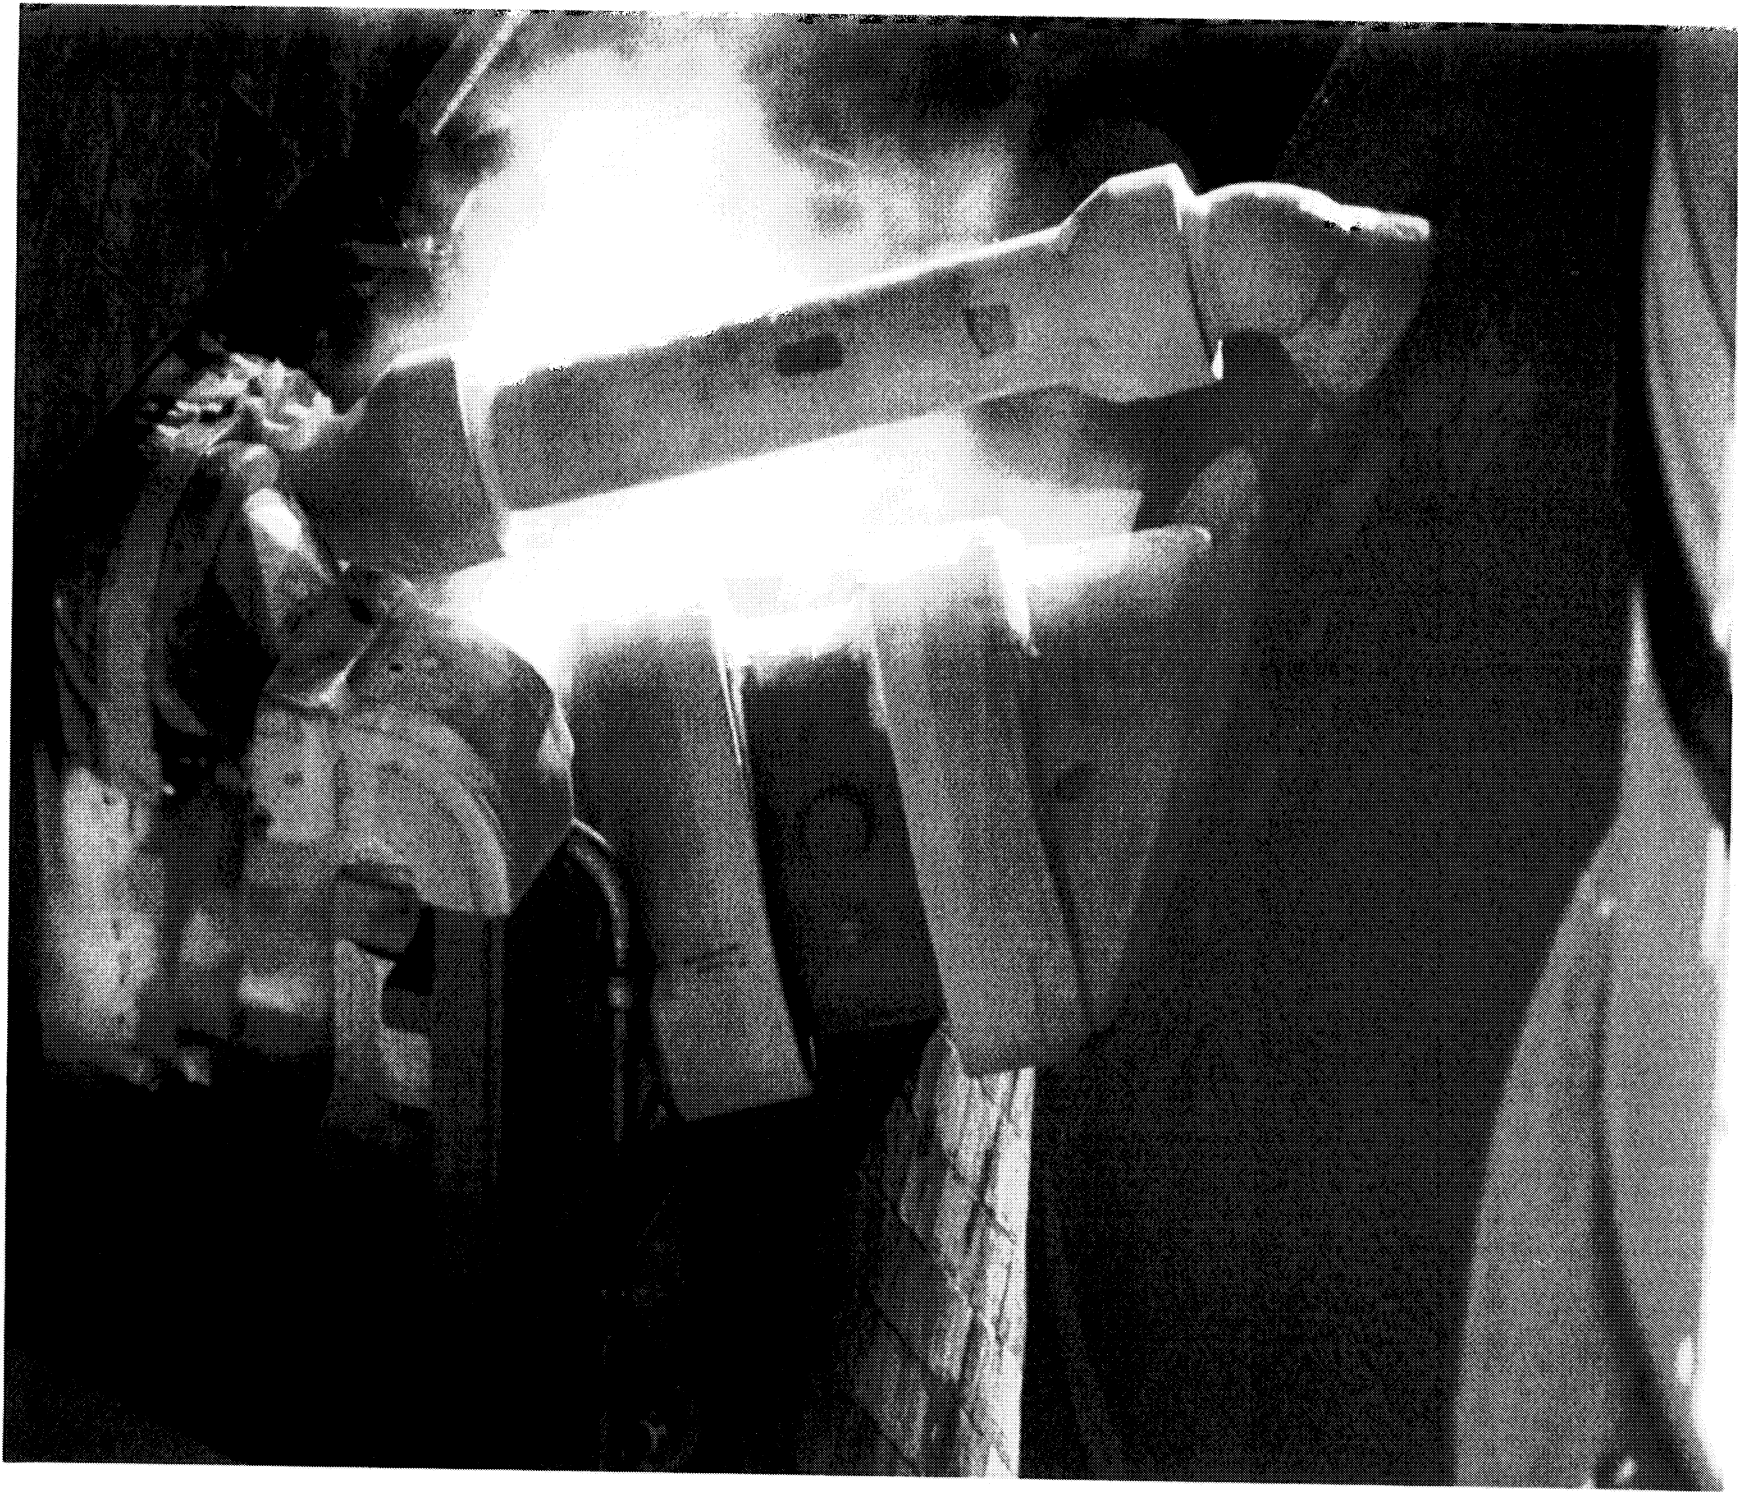
Ice/frost accumulation on the LH2 umbilical baggie, purge vents  
and in the feedline/recirc line bellows is heavier than average

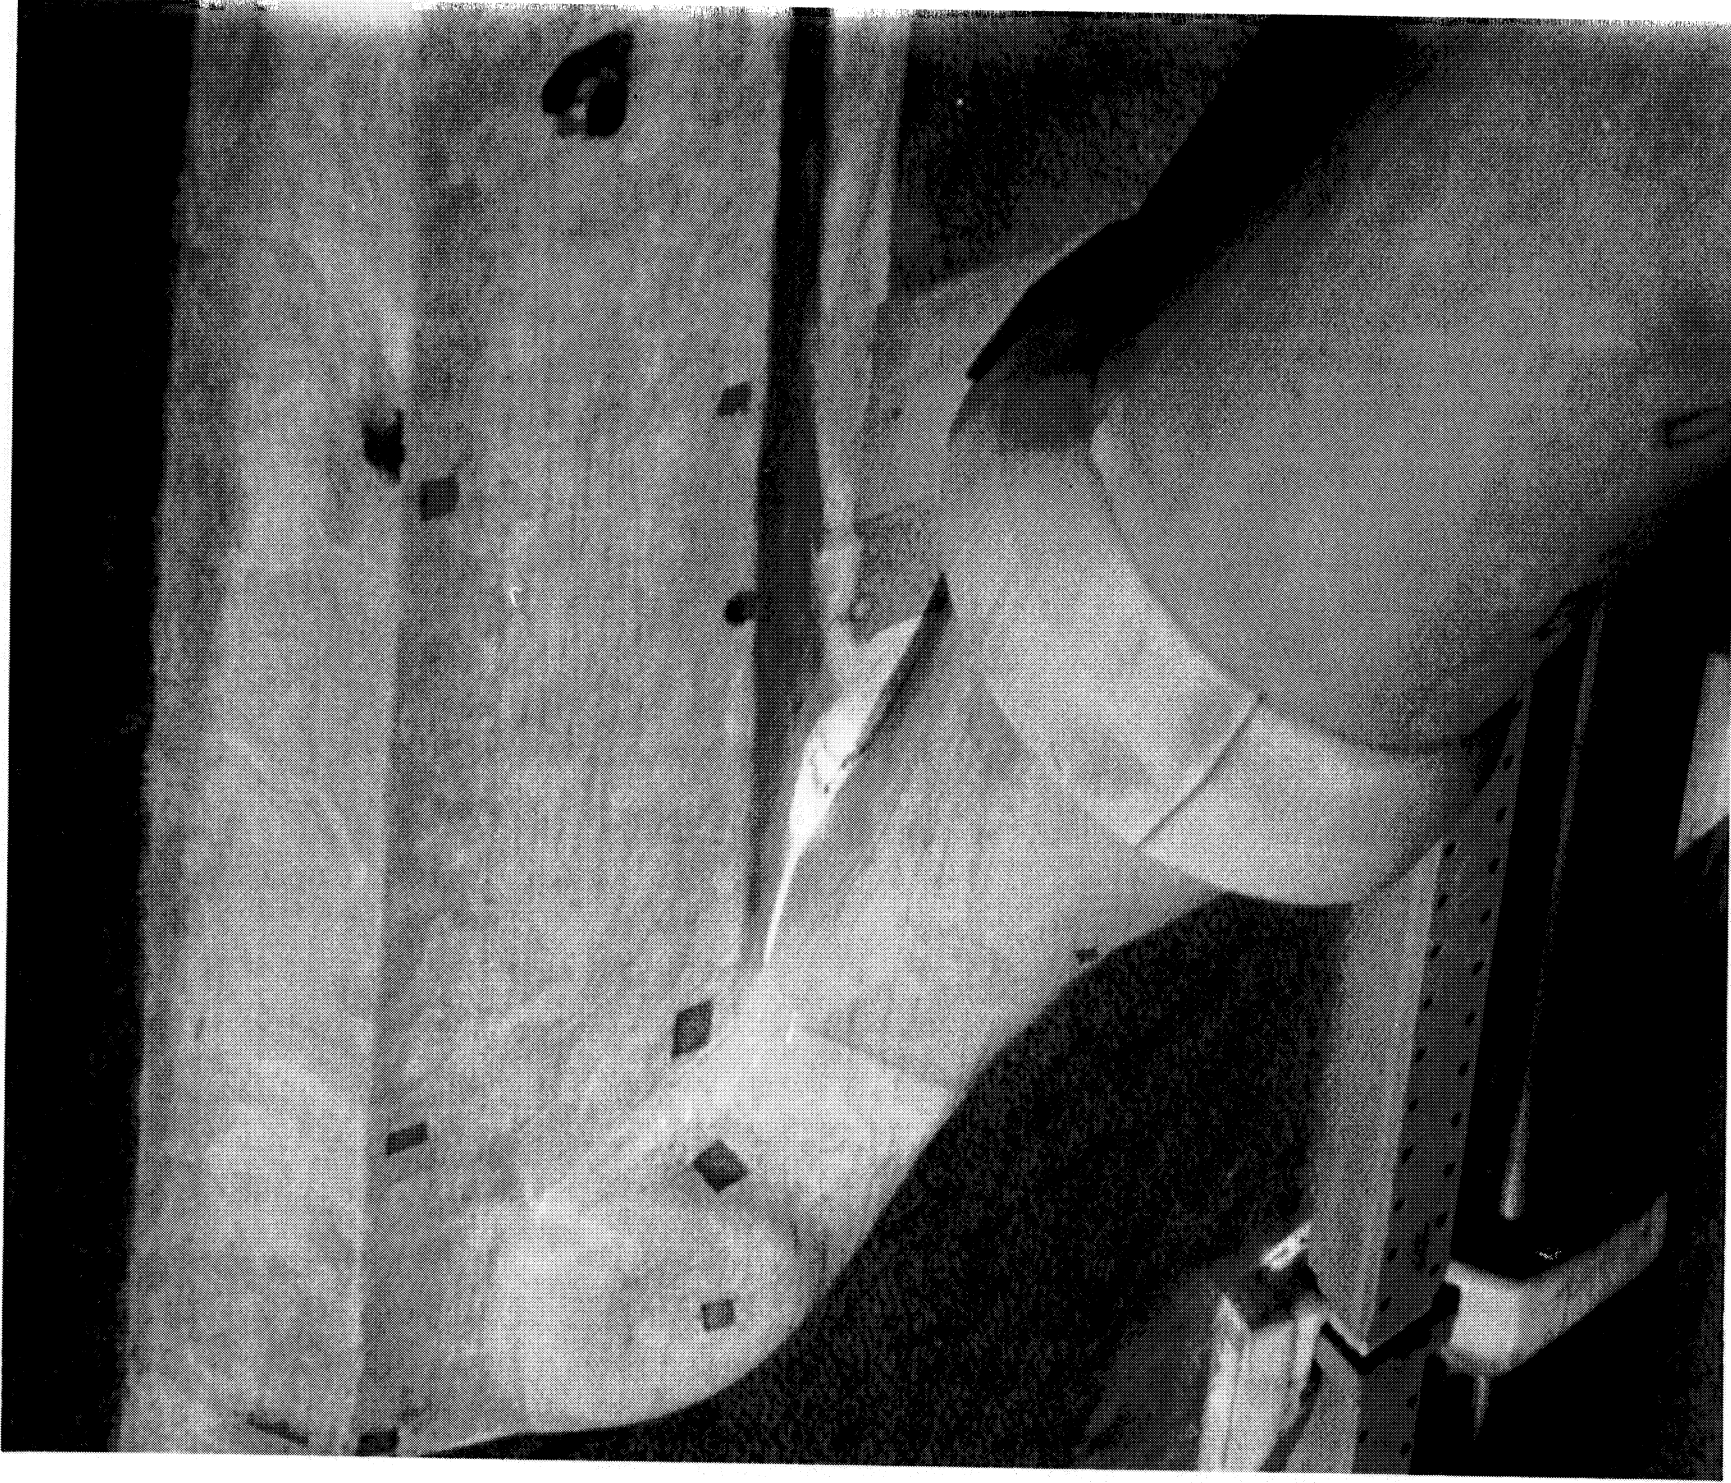
Frost has formed along the cable tray ramp aft side and in a small TPS crack at the longeron-to-thrust strut interface

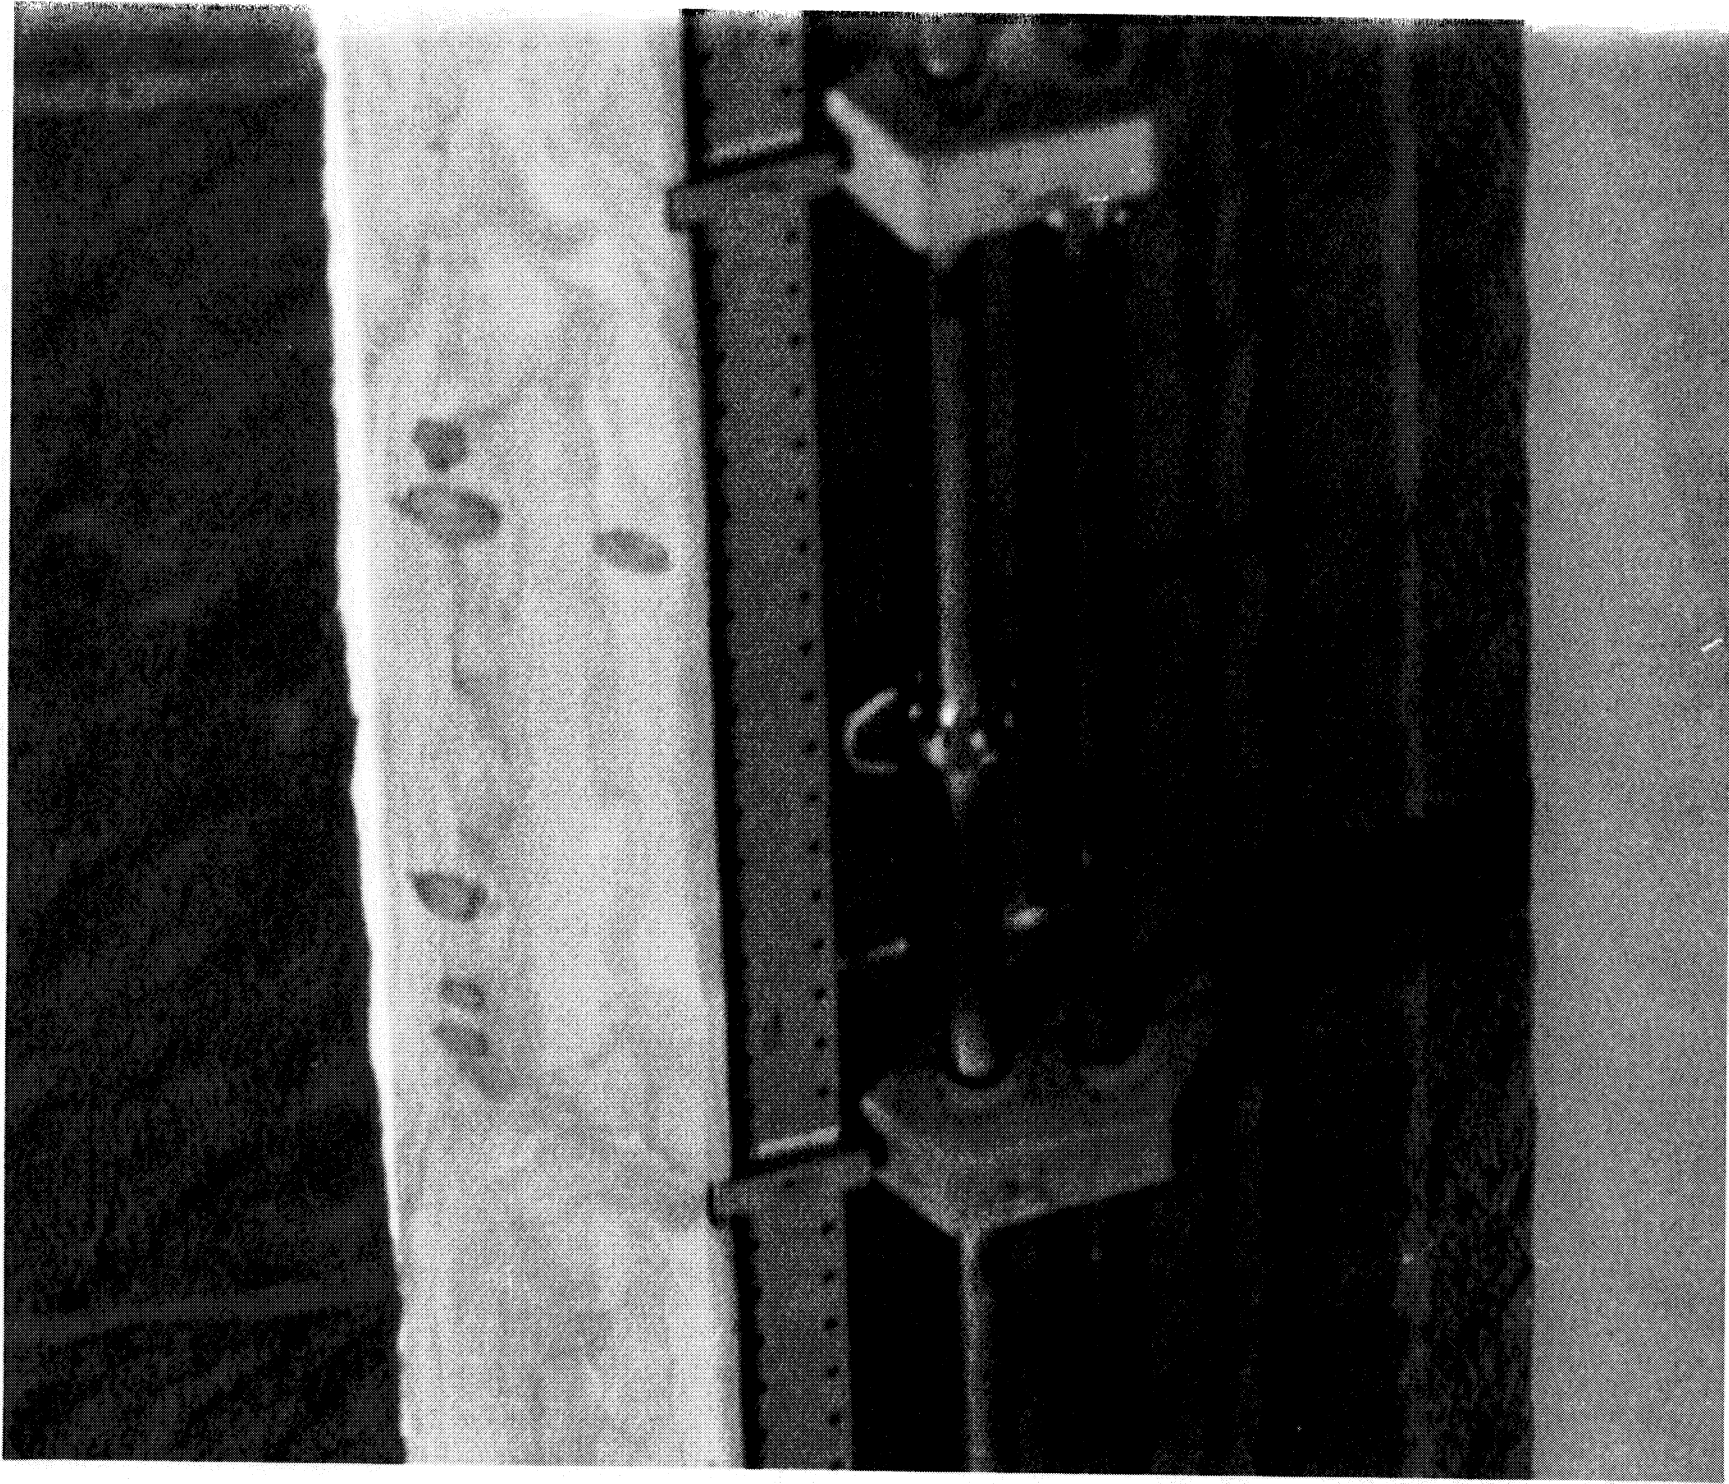
Frost outlines the LH2 tank PAL ramp, pressurization line  
ramps, and a previous 3-inch diameter repair

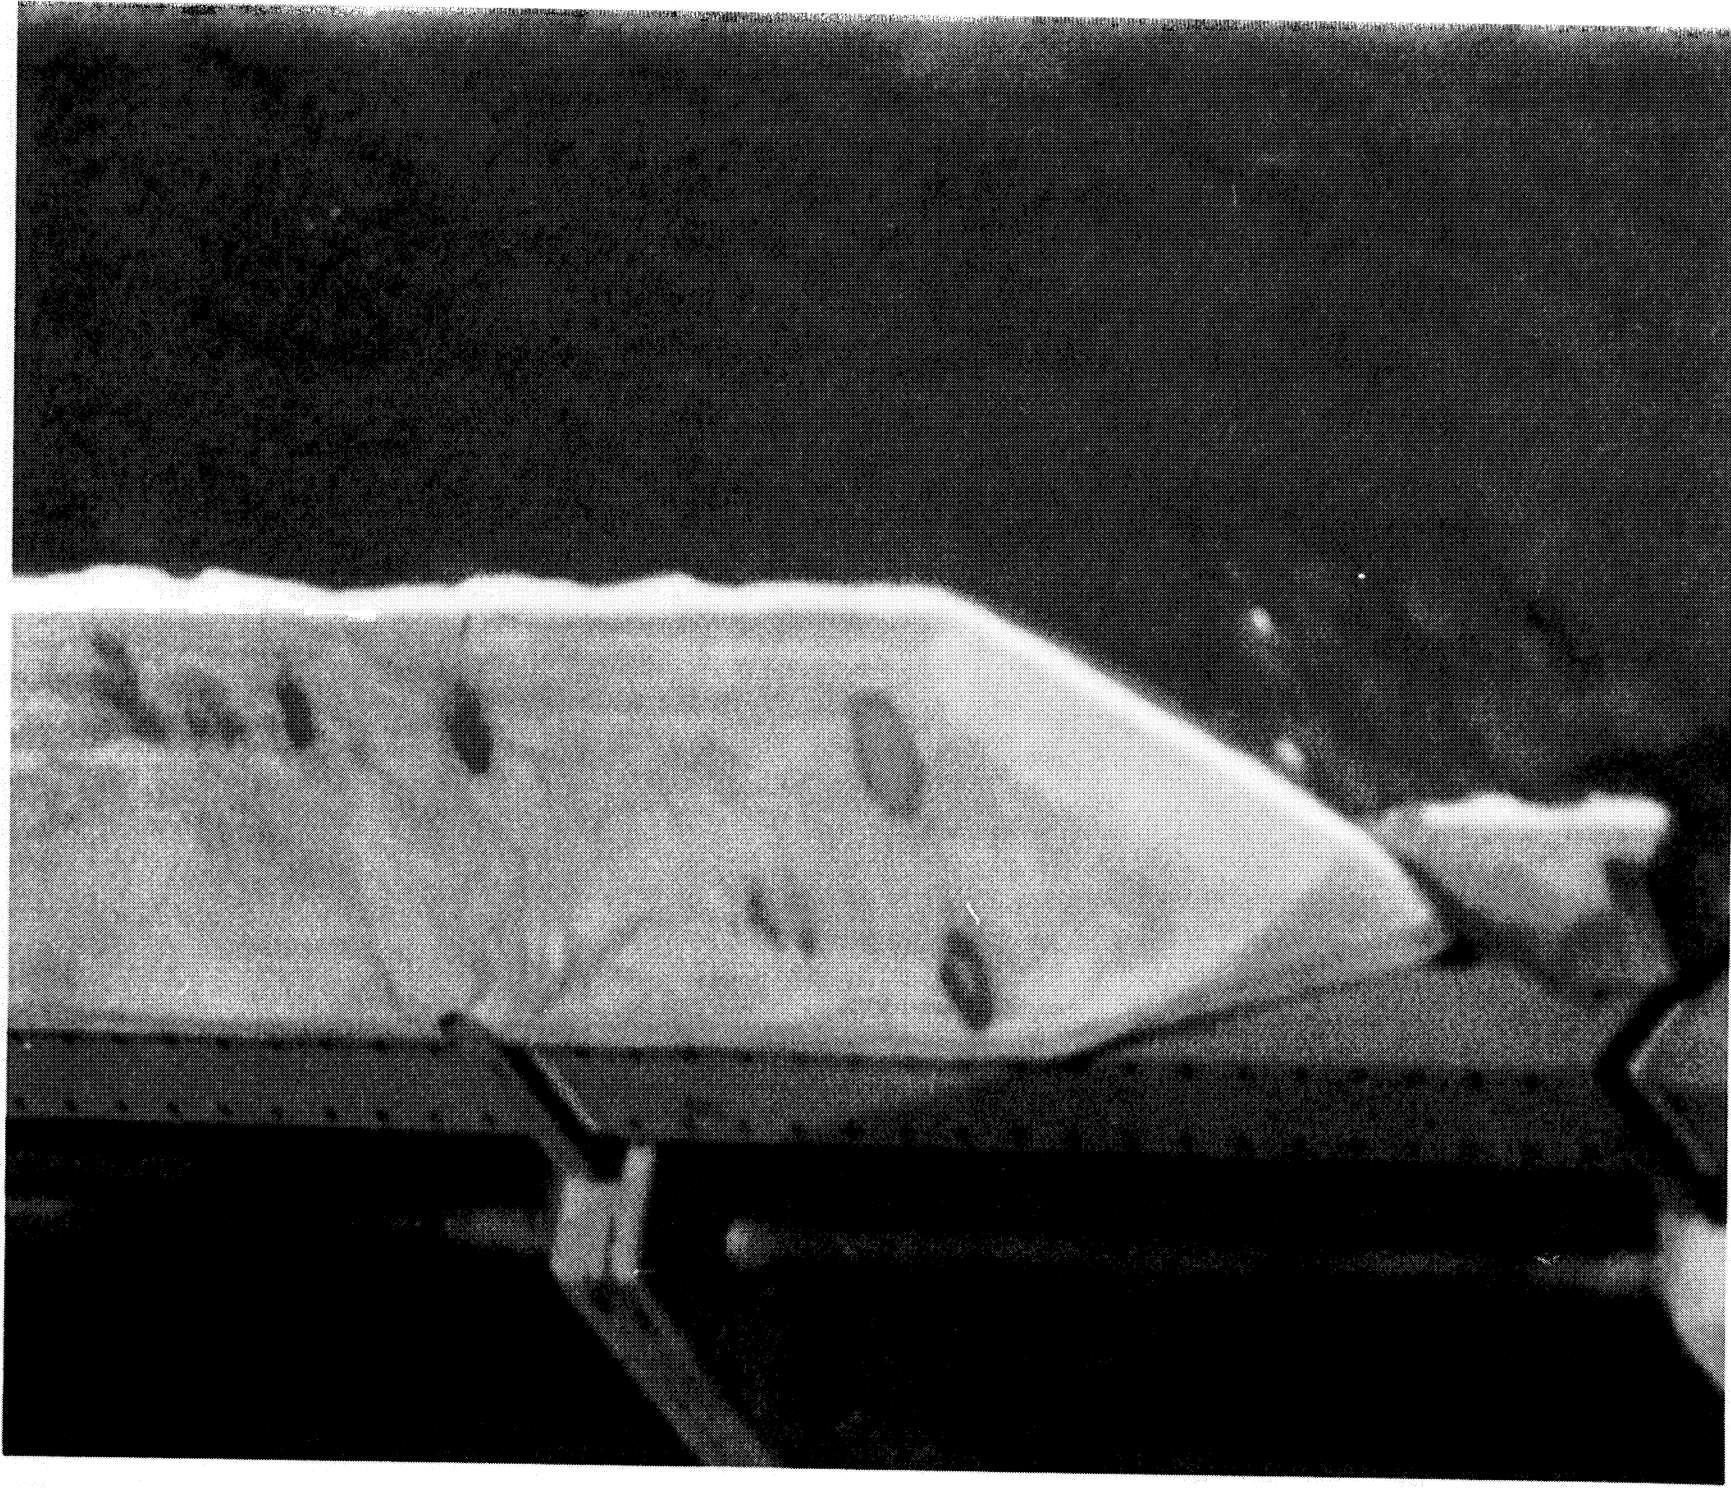
Frost outlines the LH2 tank PAL ramp, a cable tray ramp, and two small sanded areas from previous acreage repairs

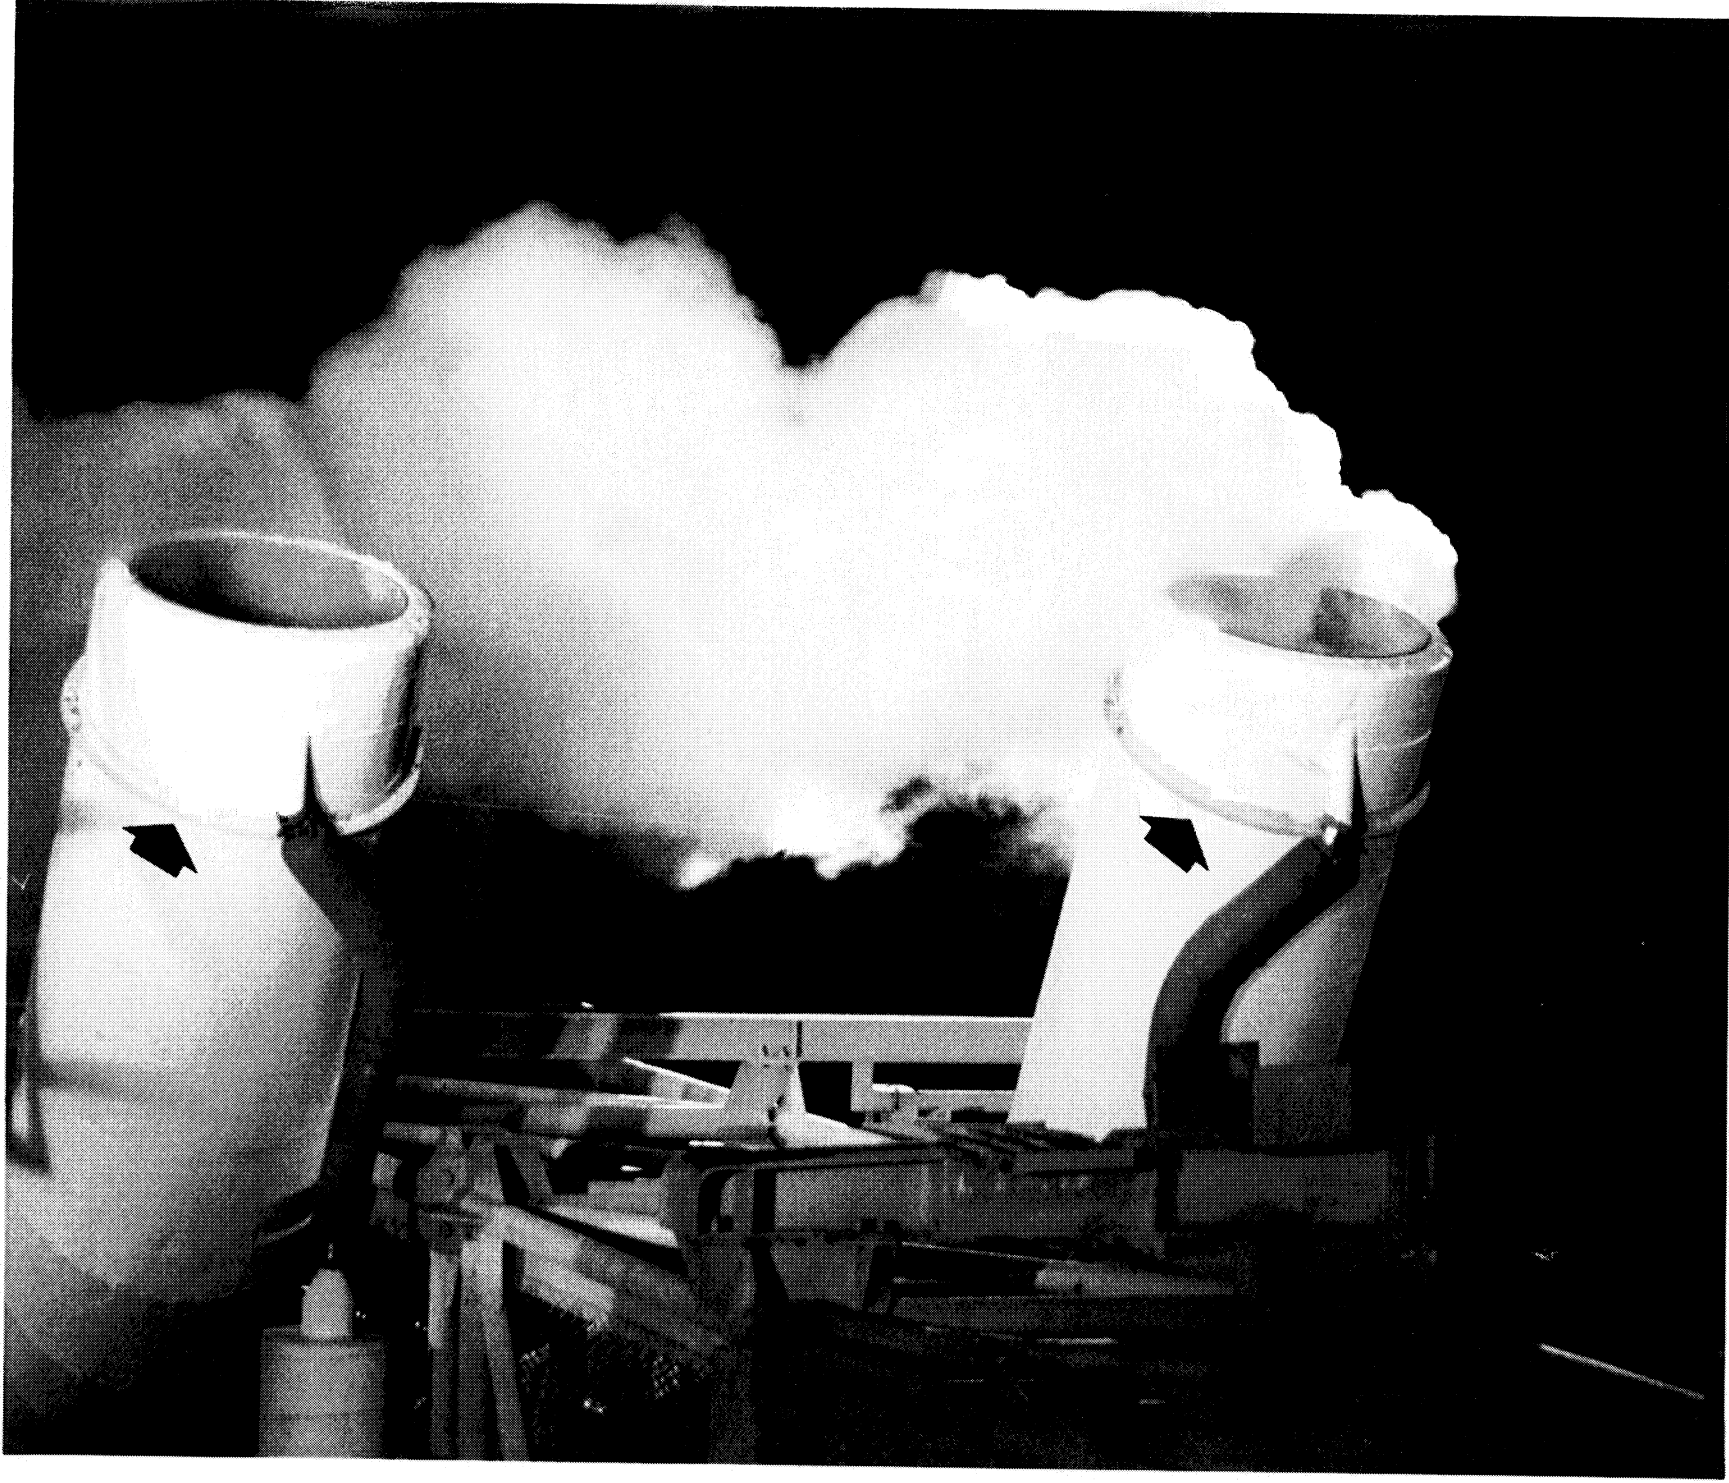
Installation of hydro diverters on the GOX vent ducts after the launch scrub precluded the formation of large icicles

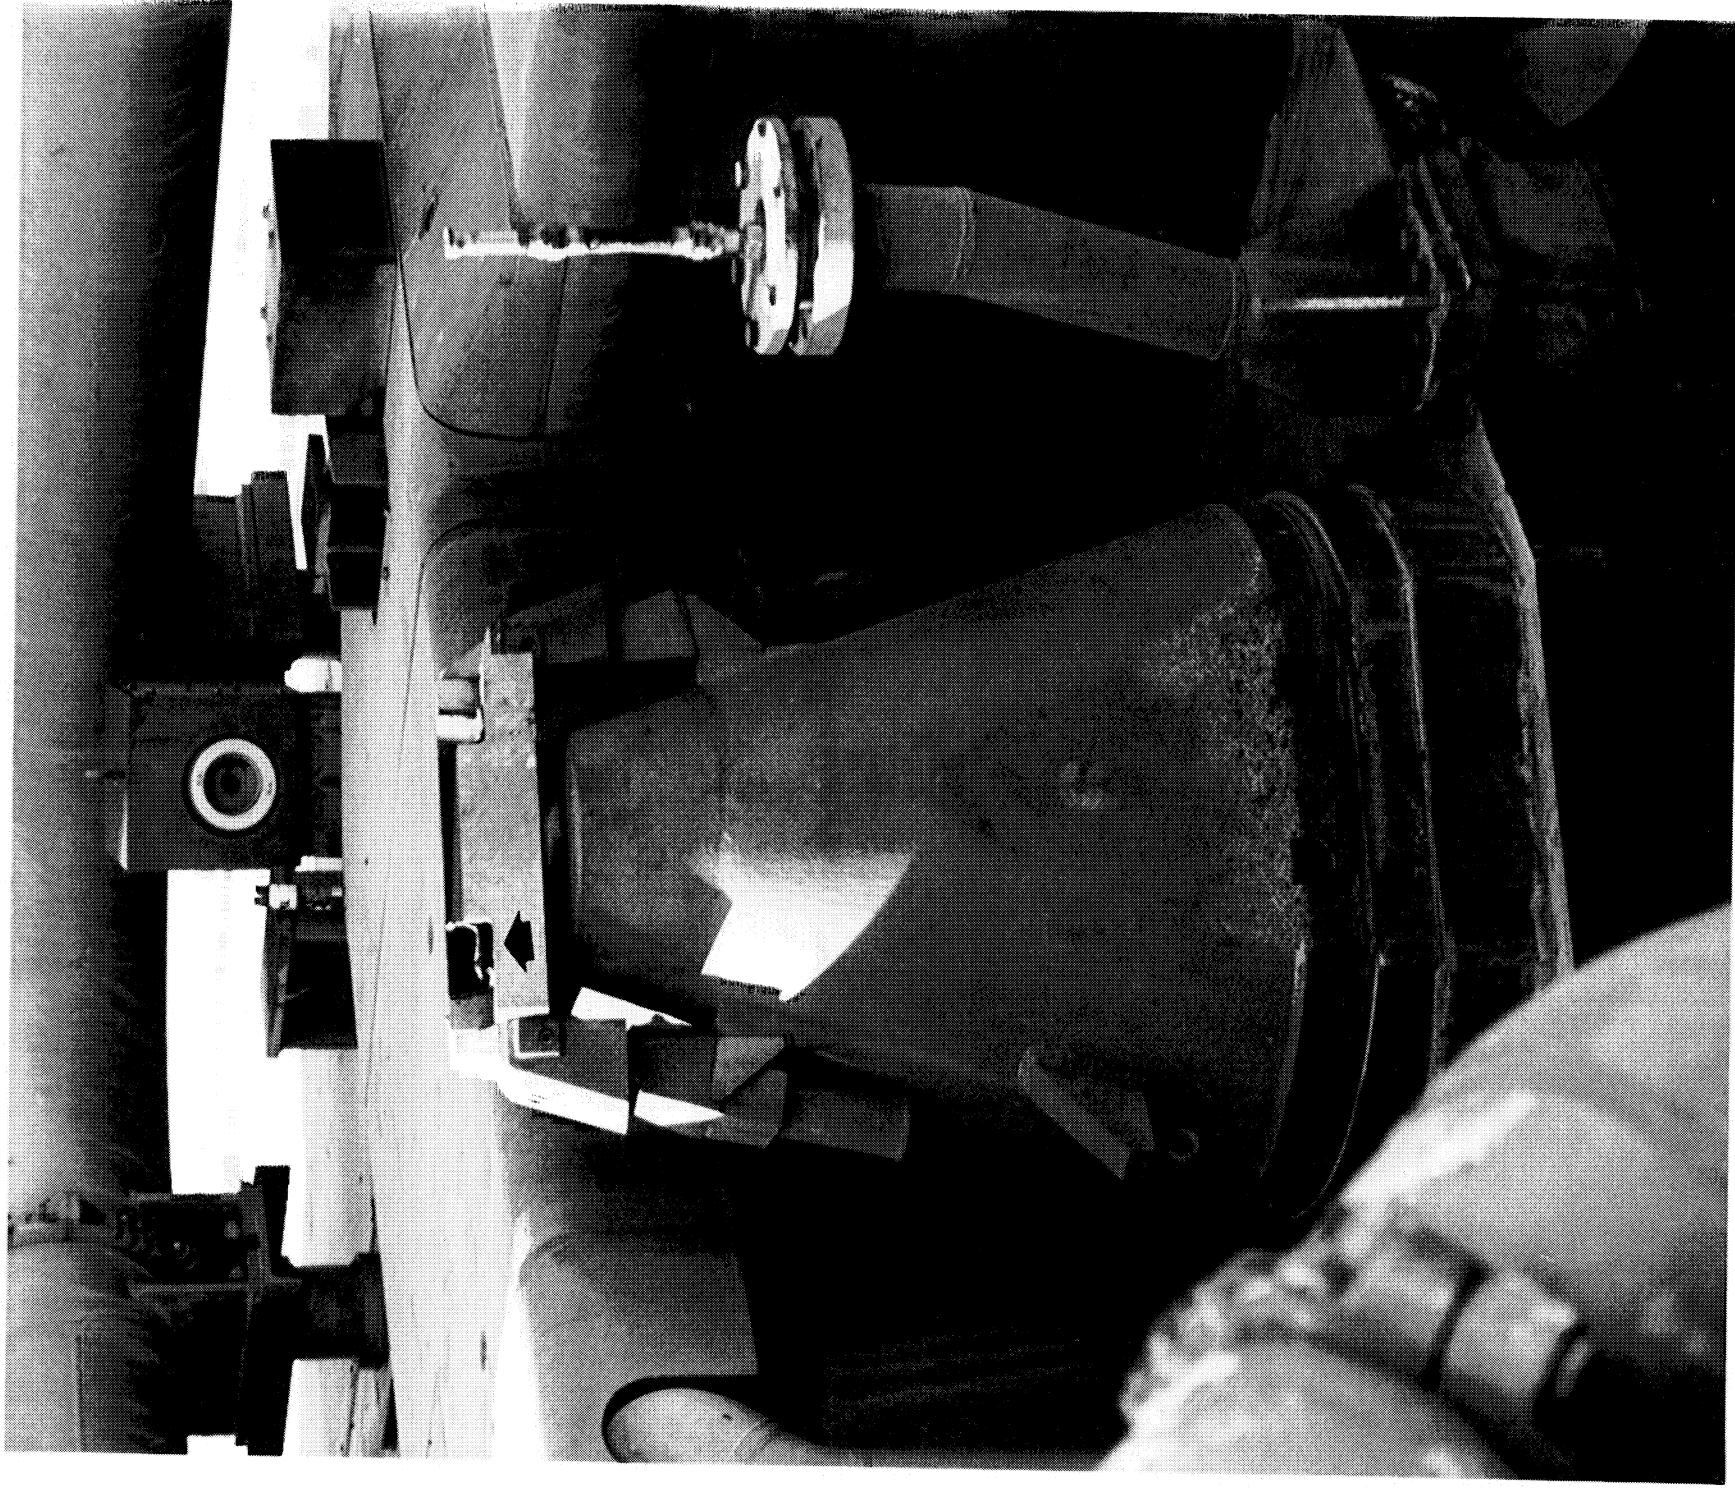
Post launch condition of a south SRB holddown post. Note debonded shim on the holddown post shoe.

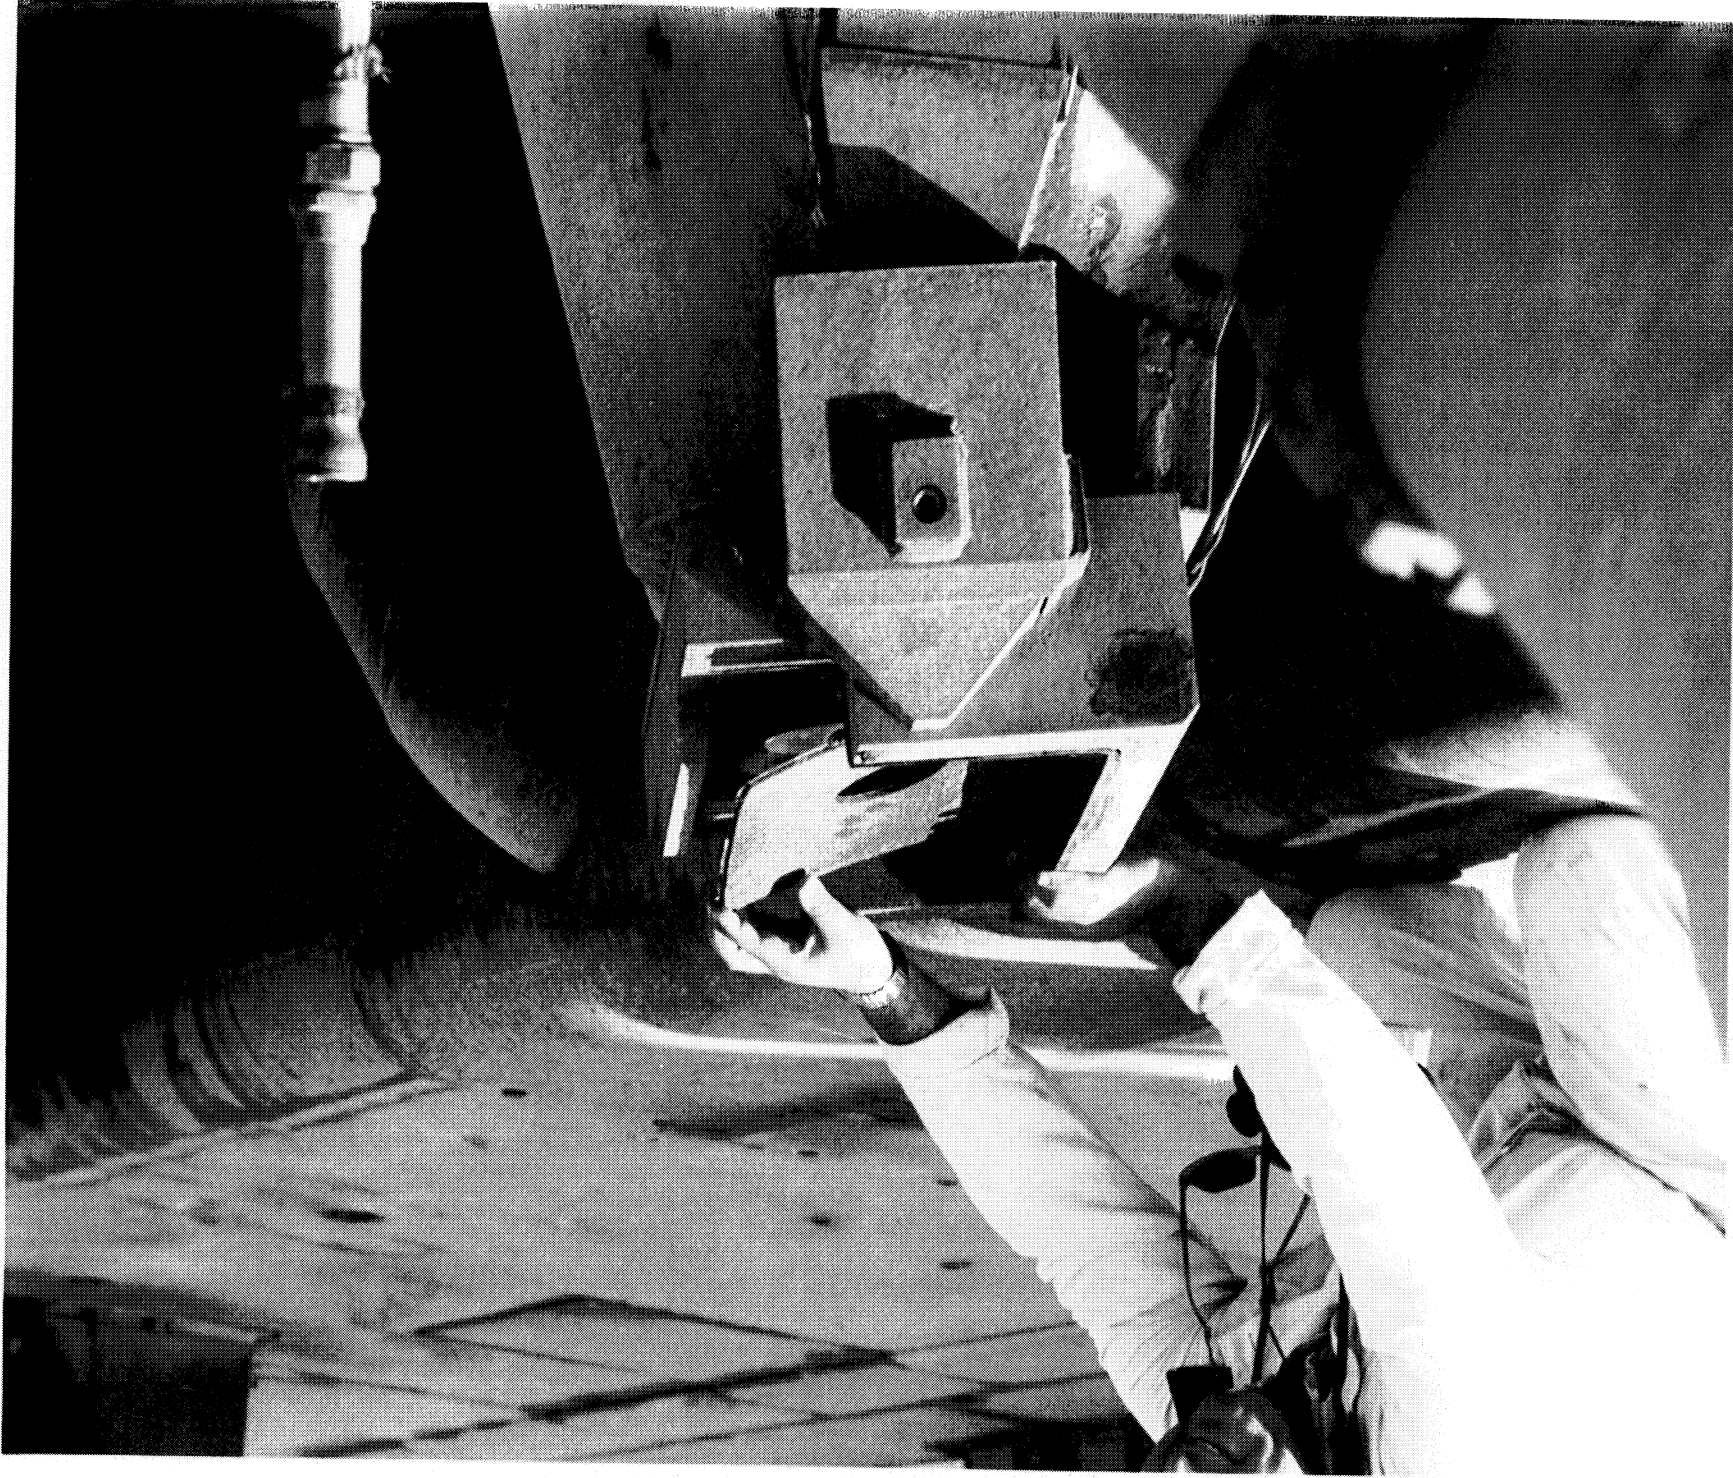
Debonded Epon shim on holddown post #2 shoe

Sidewall shim material was almost completely debonded
